RESERVE STUDY

**Sierra Los Pinos
Property Owners Association**

**Criterion Building Inspection Engineers
4801 Lang Ave NE, Suite 110
Albuquerque, NM 87109
(505) 271-1341
www.criterionNM.com**

January 6, 2017
Rev.1

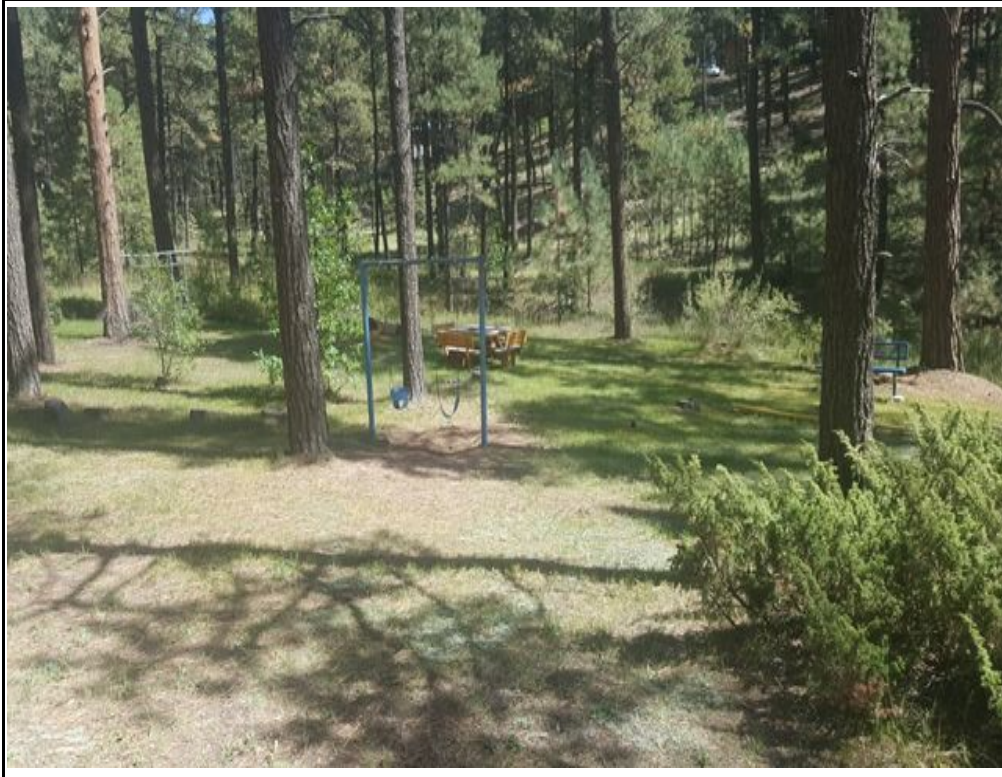
1

Park Equipment near Forest Road 10

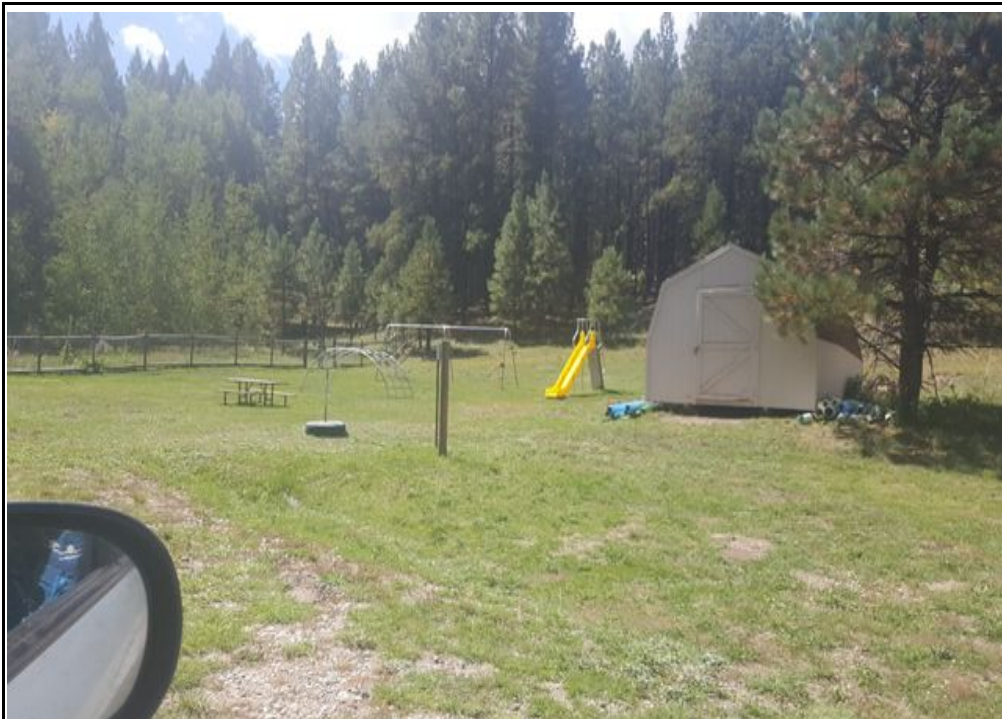
2

Park Equipment near Fire House

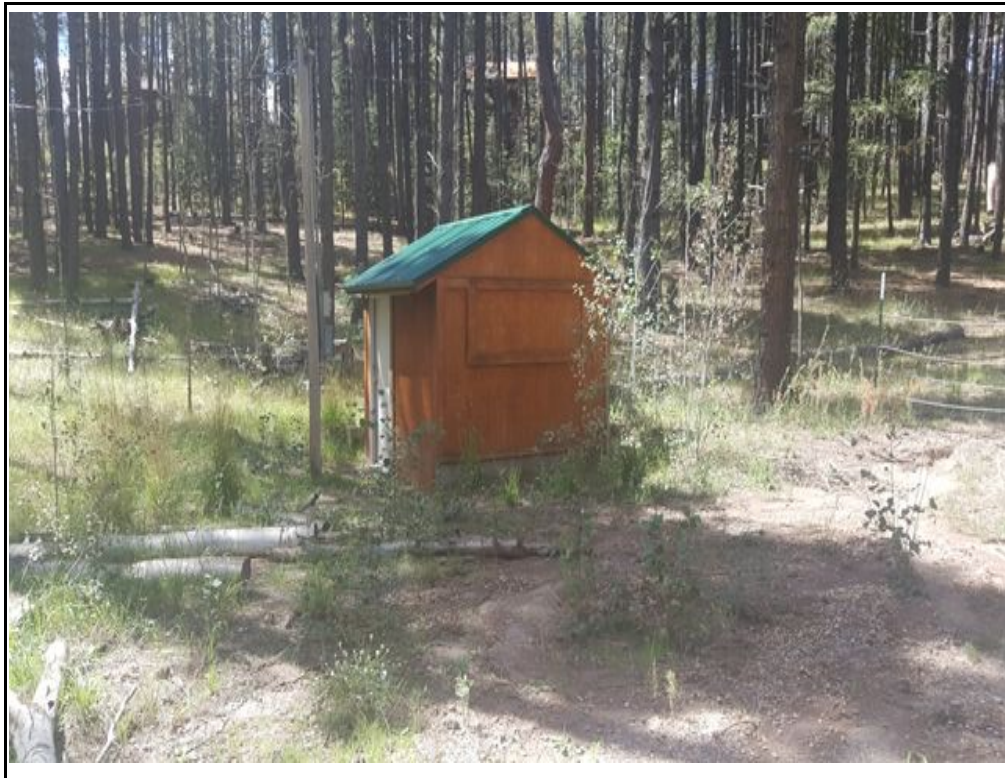
3

Hovenweep Pumphouse

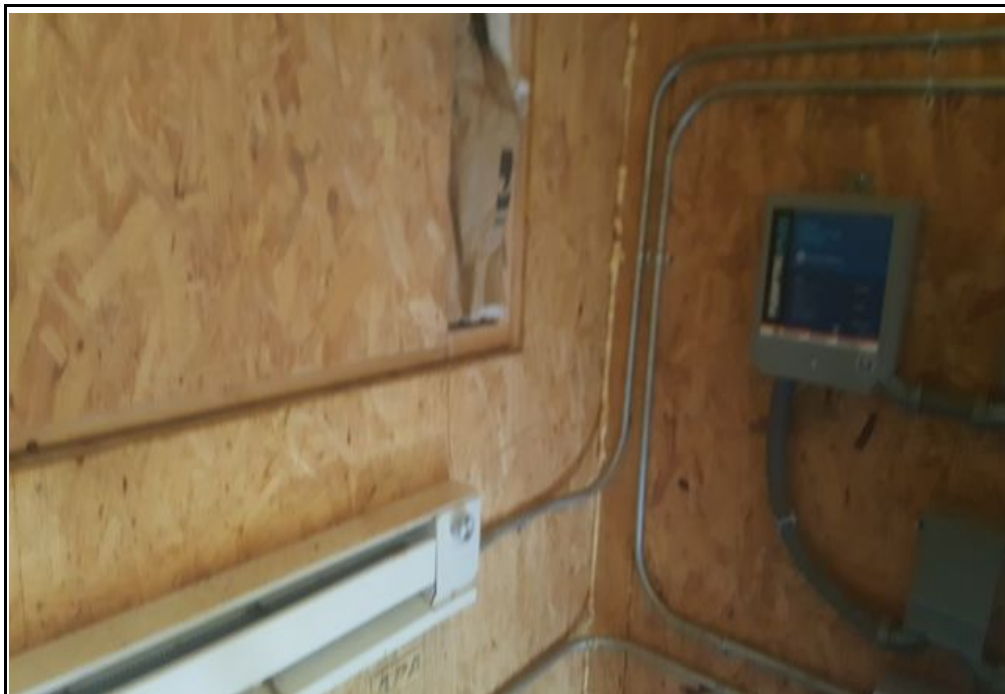
4

Hovenweep Pumphouse

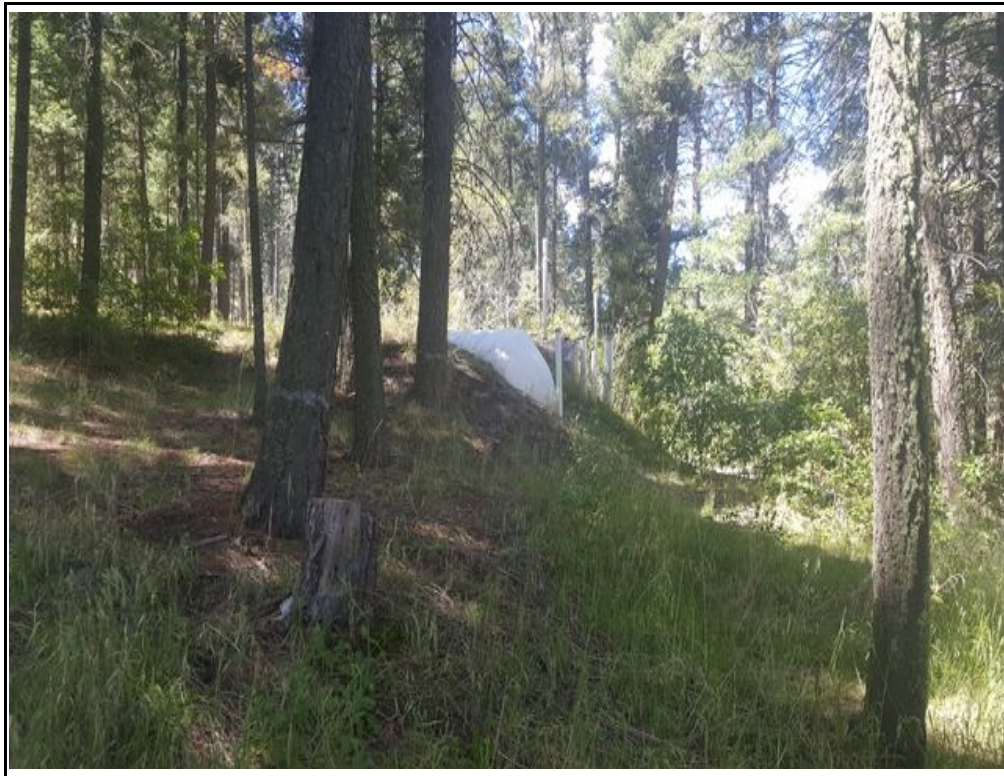
5

Water Storage Tank

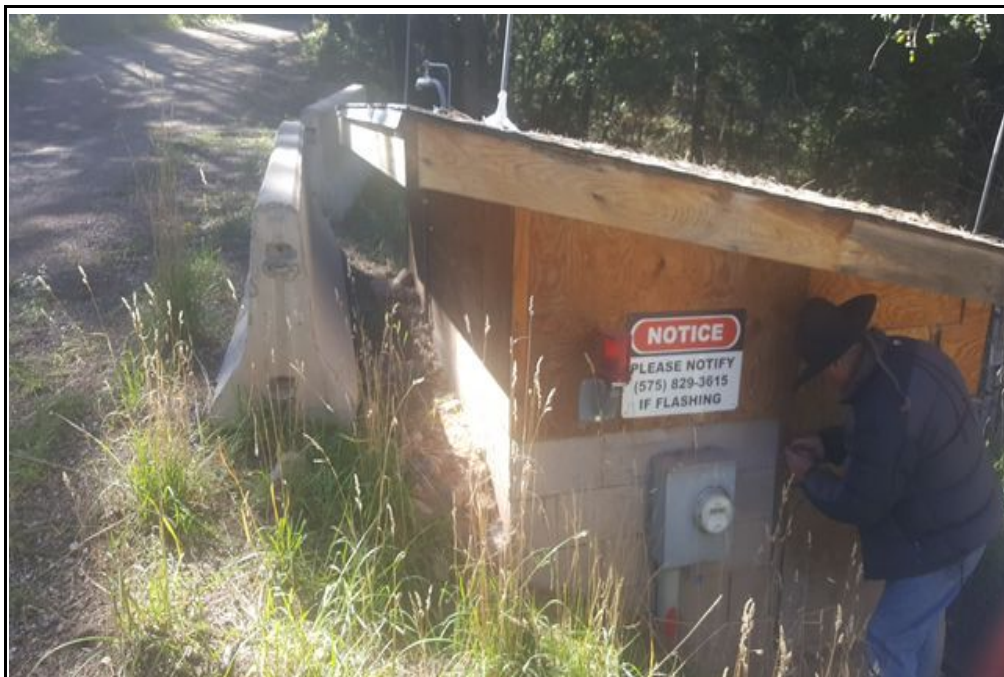
6

Booster Pump House

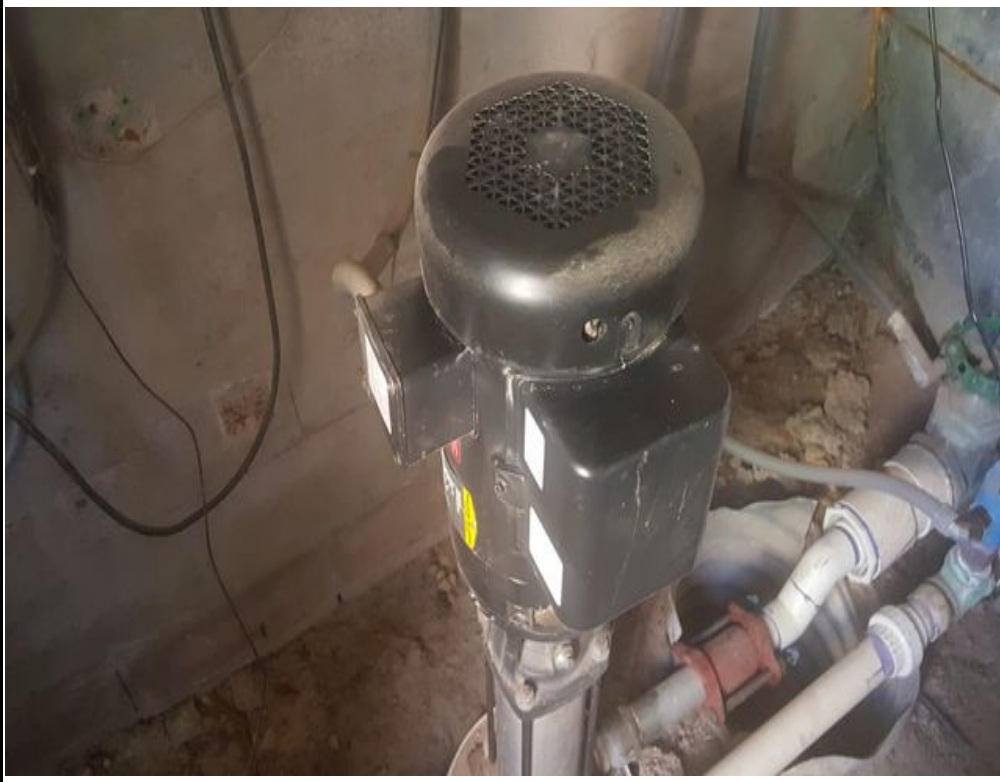
7

Pump Motor

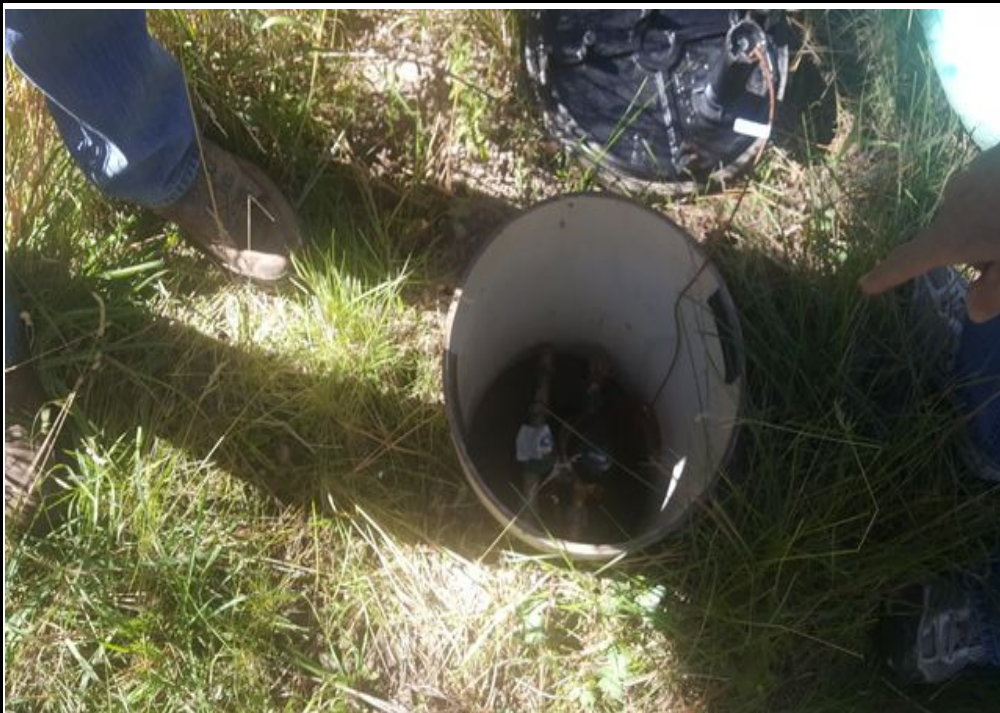
8

Water Meter

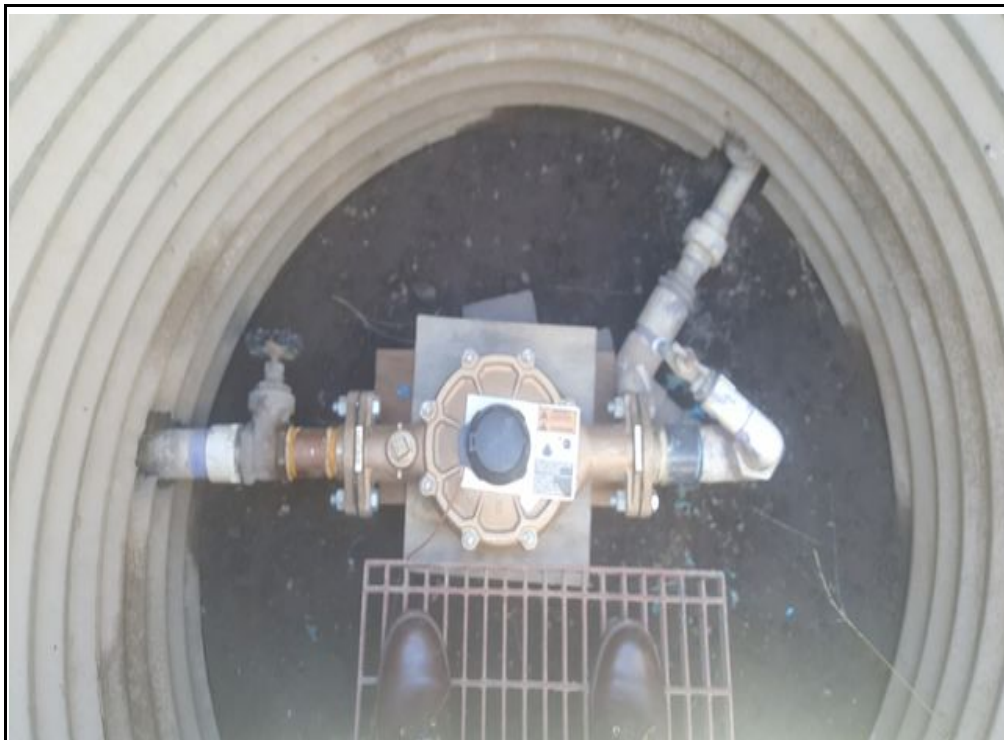
9

Valve

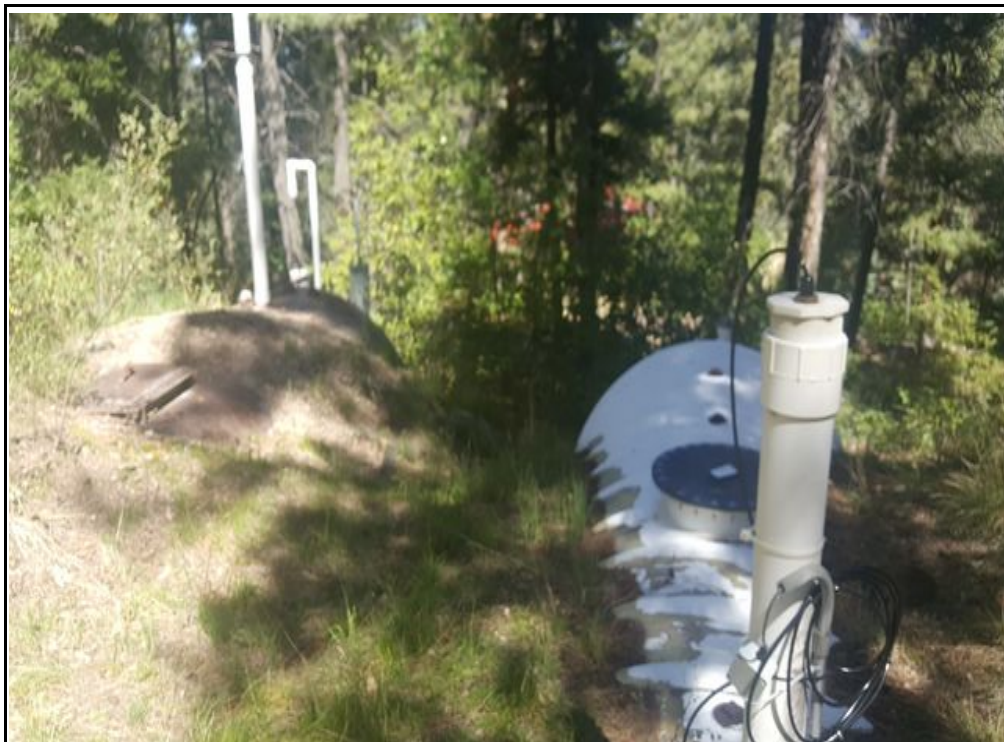
10

Water Tanks
