Re: Sierra Los Pinos, HOA, NM3565423 Sanitary Survey Report

Sanitary Survey Corrective Action Plan (CAP)

PWSS Name	Sierra Los Pinos HOA
PWSS ID	NM3565423
Sanitary Survey Date:	March 3, 2025
Date report was issued:	May 19, 2025

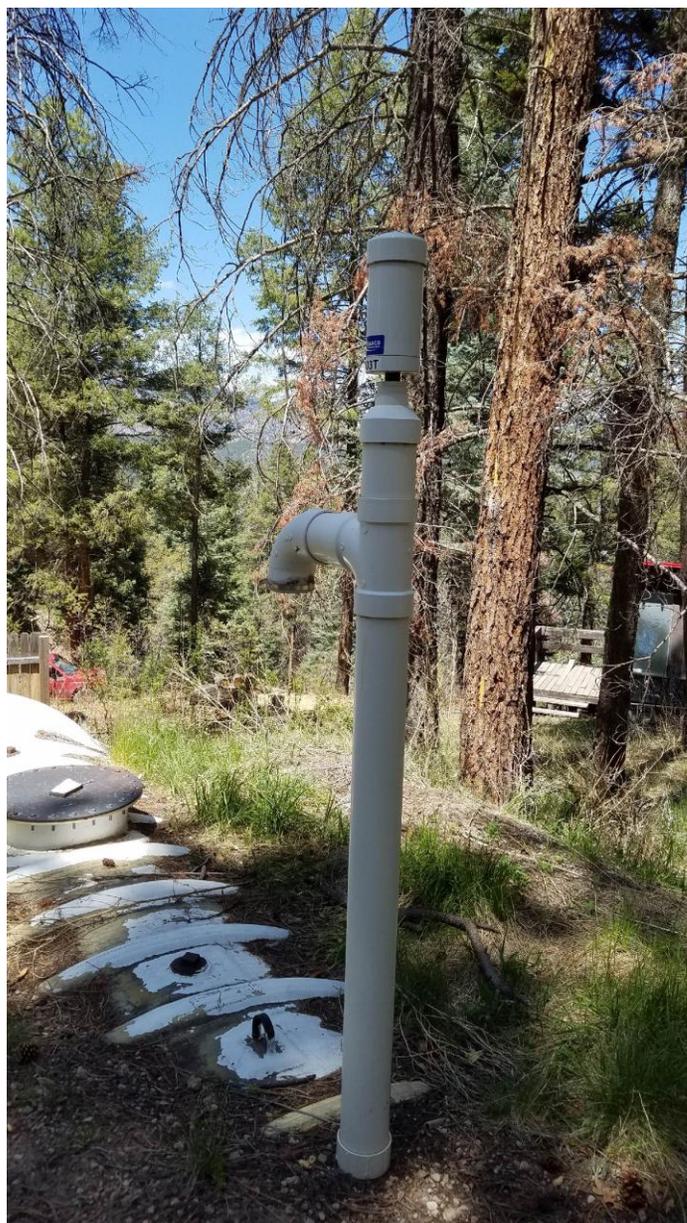
001 B - Failure to provide an overflow line to prevent contaminants from entering the tank. This deficiency applies to storage tanks #1 (#010), Storage Tank #2 (#012), Storage Tank #3 (#013), Storage Tank #4 (#014), Storage Tank #5 (#015)

Storage Tank 1 Screened Overflow Vent

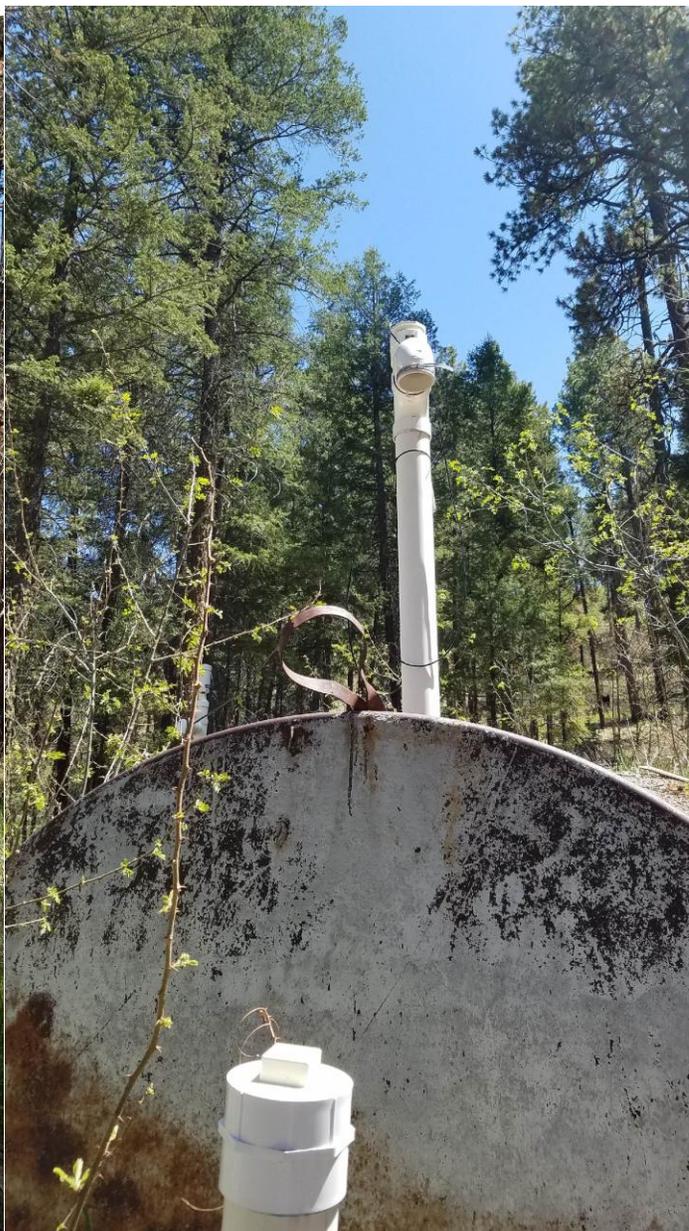
Storage Tank 2 Screened Overflow Vent

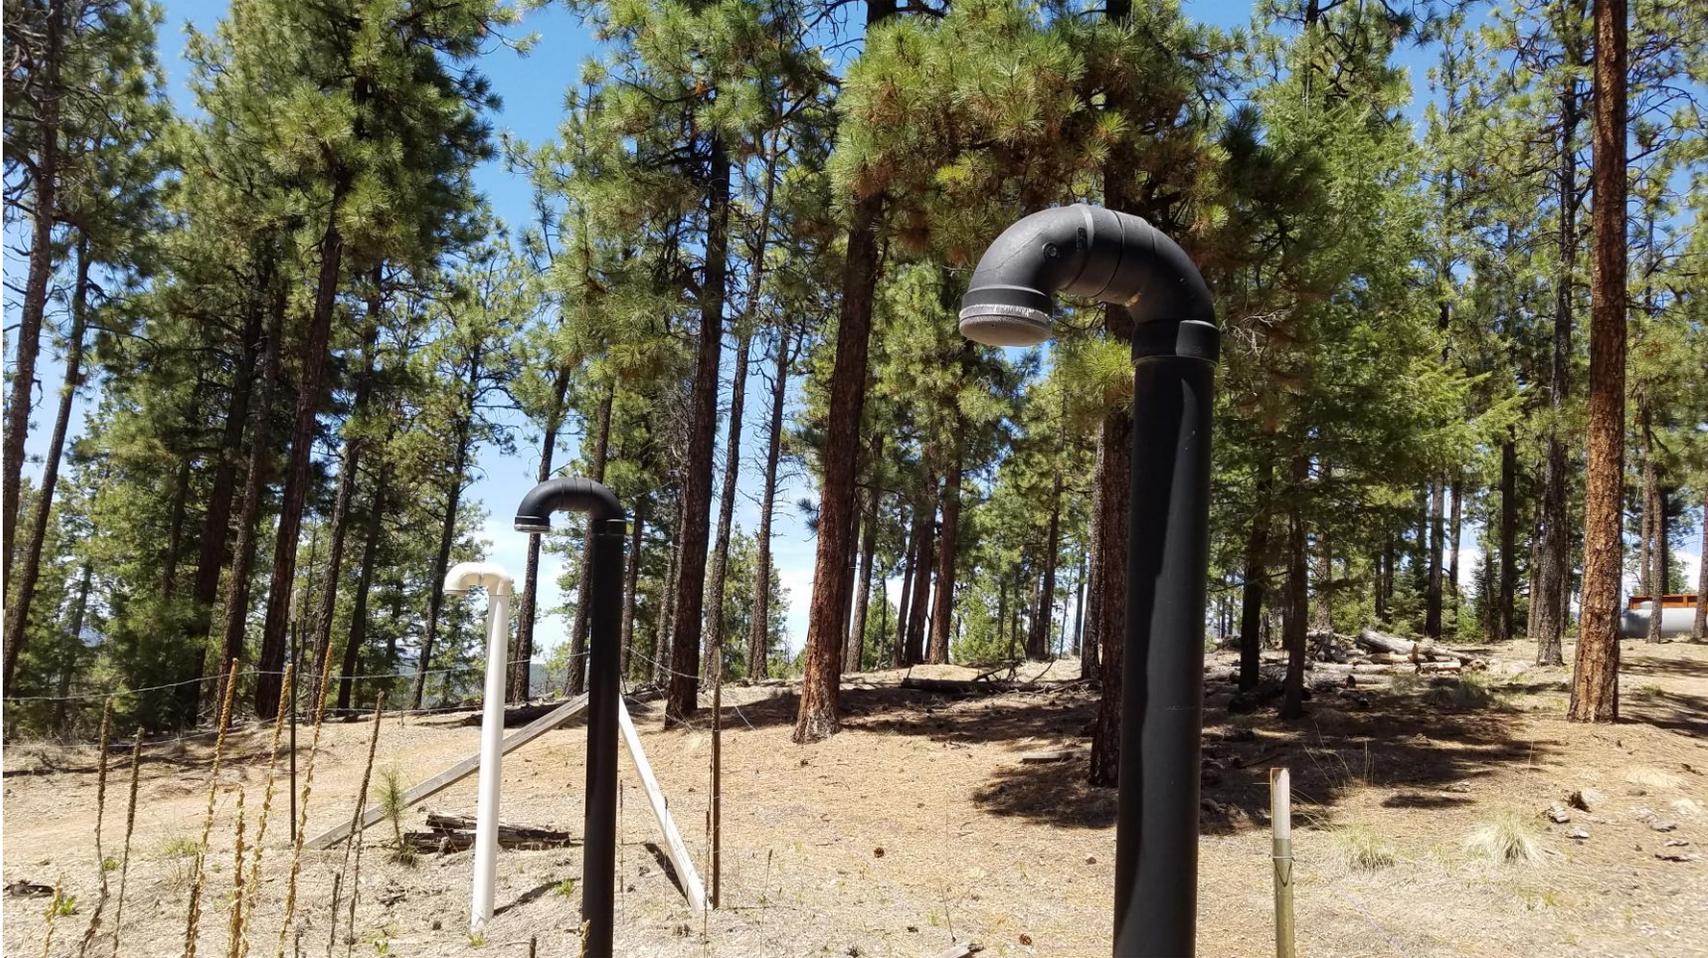
Storage Tanks 3 – 5 Screened Vents

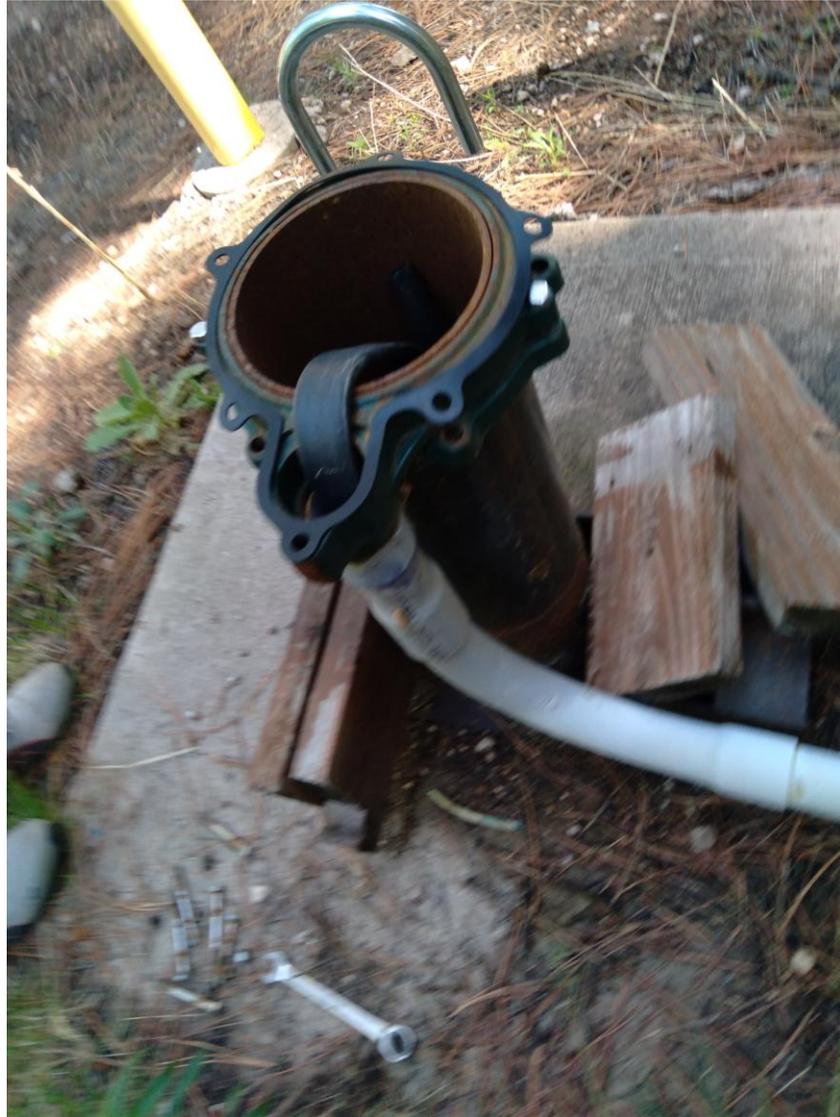
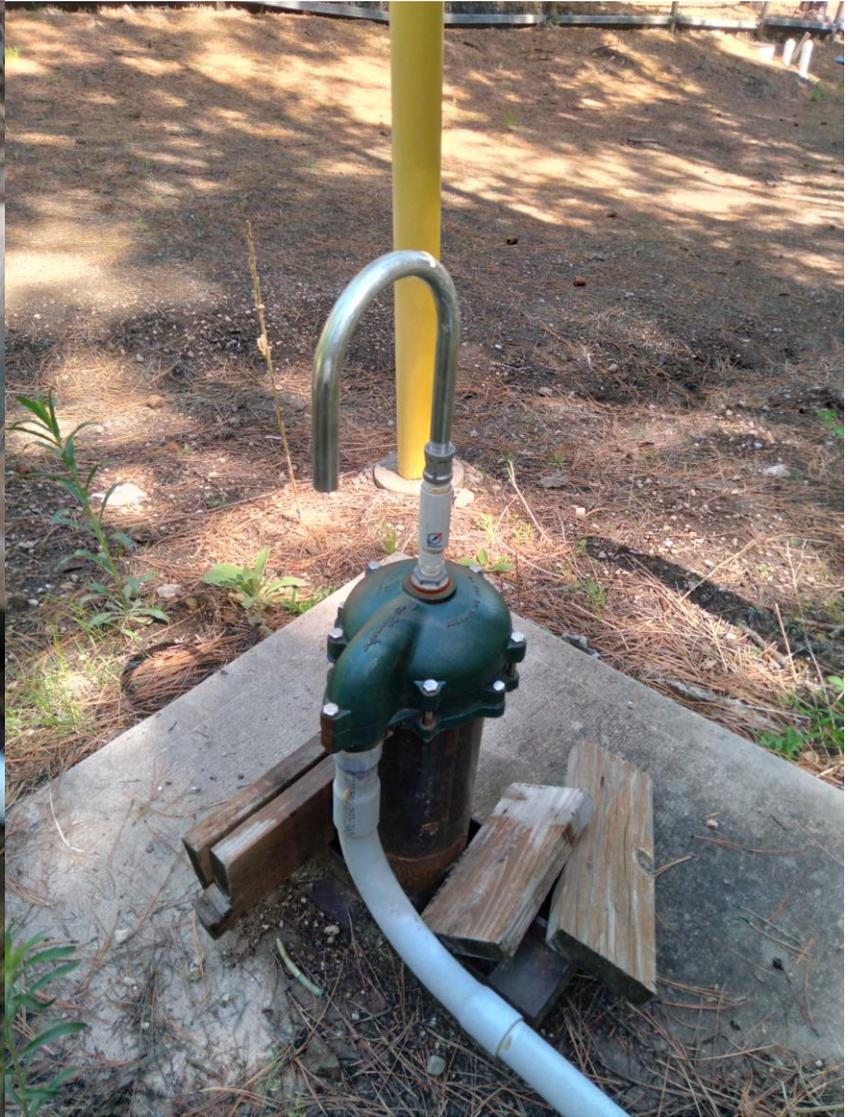
Aspen Well Gasket and Vent Wellhead

Comments:	
1	Loose bolts were tightened on 3/18/2025. Hydrogeologic Services (HGS) installed new sanitary vents on June 10, 2025.
2	Loose bolts were tightened on 3/18/2025. Hydrogeologic Services (HGS) install new sanitary vents on June 10, 2025
3	Draft of the ERP in process and an approved plan expected by 9/1/2025
4	Review of the 2014 O&M in process and an approved plan expected by 9/1/2025
5	Initiated procurement of appropriate seals. They are not available from Baker Utility Supply in Albuquerque, NM, our regular parts supplier. We have contacted Mountain West Tank Resources to procure appropriate gaskets/seals.
6	All storage tanks have appropriately screened overflow vents in place and have been for many years. Photos to document are attached.
7	Tank was inspected in July 2023 by CWW Divers. At that time, they advised recoating in 3-5 years. We had planned to recoat or replace the tank in 2026. Currently seeking a bid on tank replacement, with completion depending on availability of suitable tank and contractor.

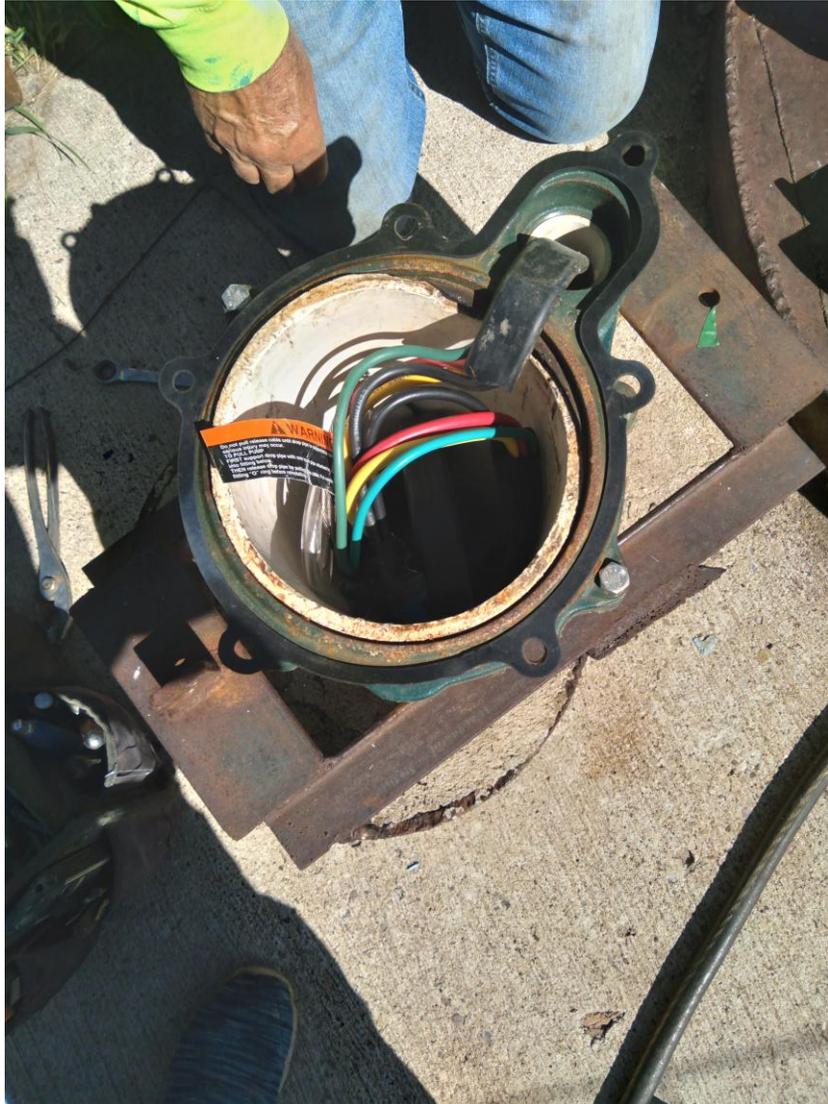
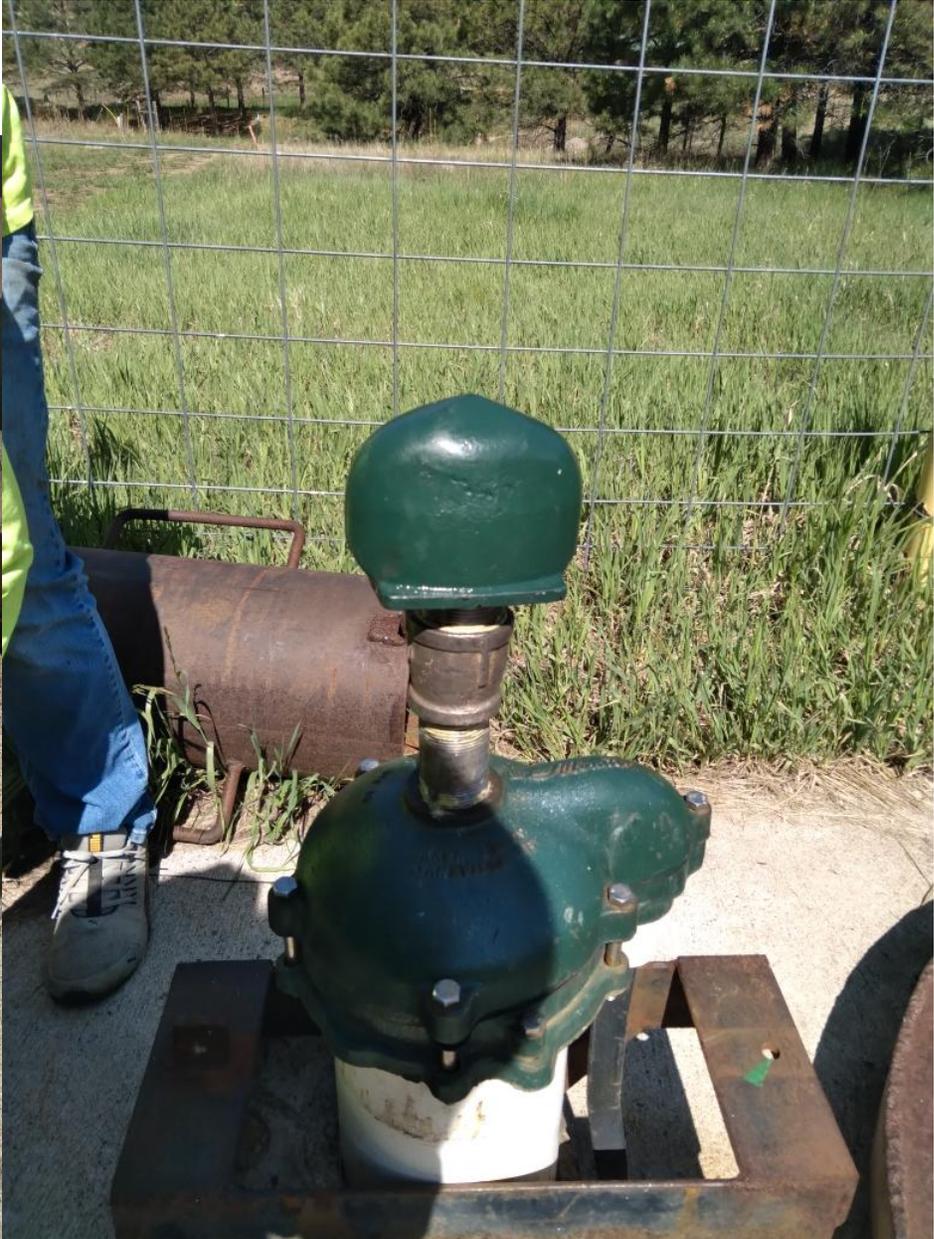
Forest Road 10 Gasket and vented Wellhead
