RE: 2025 Sanitary Survey Report

SANITARY SURVEY REPORT

Sierra Los Pinos HOA NM3565423

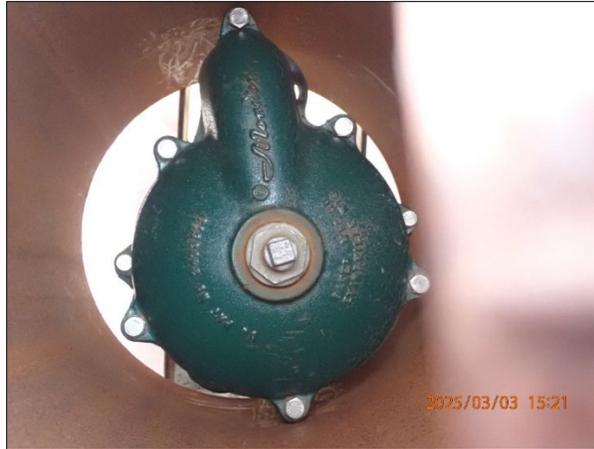
Photograph 1 Sierra Los Pinos HOA

- 001K, Well lacks a proper vent. Refer to Photographs 1 and 2.
 - Forest Well – 007 - As of the day of the 2025 sanitary survey, the well did not have a proper vent.
 - Aspen Well – 003 - As of the day of the 2025 sanitary survey, the well did not have a proper vent.

Description: Forest Well – 007 – Several of the eight (8) well cap bolts that could be observed were loose and not secured. The well cap does not have a vent.

2. **Notes & Recommendations:** Forest Well – 007 and Aspen Well – 003 have loose bolts on the sanitary seal on the wellhead. No visible gap in the seal was observed. Refer to photographs 1 and 2.

Recommended Action: It is recommended that the system tighten the bolts on the wellhead to ensure a complete seal around the wellhead is maintained.

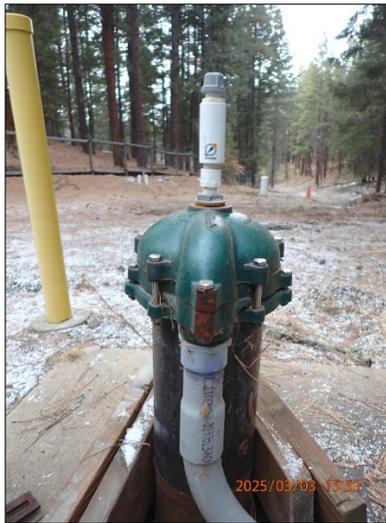
Photograph 2. Sierra Los Pinos HOA

Description: Aspen Well – 003 – Several of the (8) well cap bolts were loose and not secured. The well cap does not have a vent. System representatives described the feature on top of the well as potentially a water level sensor from a prior project that is not functioning.

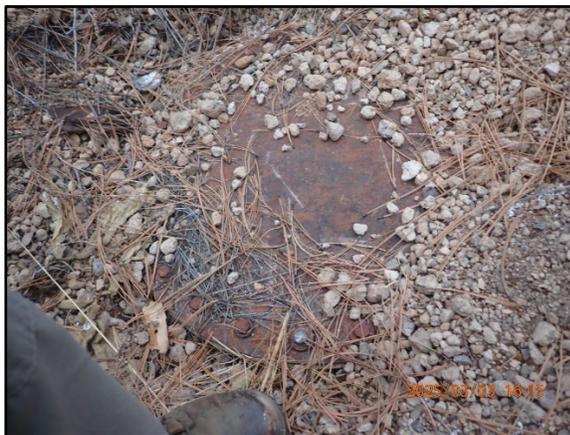
Photograph 4. Sierra Los Pinos HOA

- a. Storage Tank #1 - 010 – Missing hatch seal.
- b. Storage Tank #2 – 011 - Incomplete and deteriorated hatch seal
- c. Storage Tank #3 – 012 - No observation of an effective seal.
- d. Storage Tank #4 – 013 – No observation of an effective seal.
- e. Storage Tank #5 – 014 – No observation of an effective seal.

Description: Storage Tank #3 - 012, #4 - 013, or #5 – 014

Hatch lid is bolted to the access at ground level or below grade and a seal could not be observed. The type and style of the access is similar for the three (3) tanks listed in the description.

Required Corrective Action: Sierra Los Pinos HOA must submit to NMED DWB photographs that show evidence that the storage tank access hatches are adequately sealed and protected from contamination.

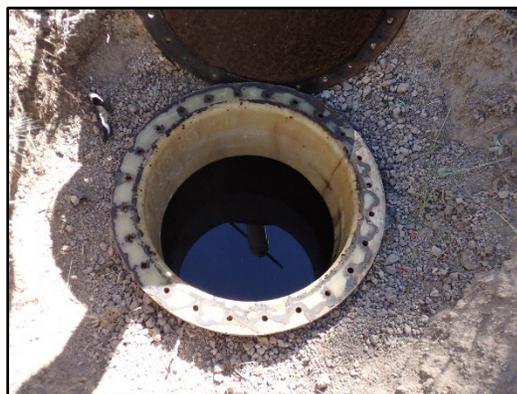
Photograph 5. Sierra Los Pinos HOA

Description: Storage Tank #3 - 012, #4 - 013, or #5 – 014 access hatch photograph provided by Sierra Los Pinos HOA from a 2023 inspection. Hatch is at ground level or below grade and has an incomplete and deteriorated seal that was not observed as replaced after the inspection.

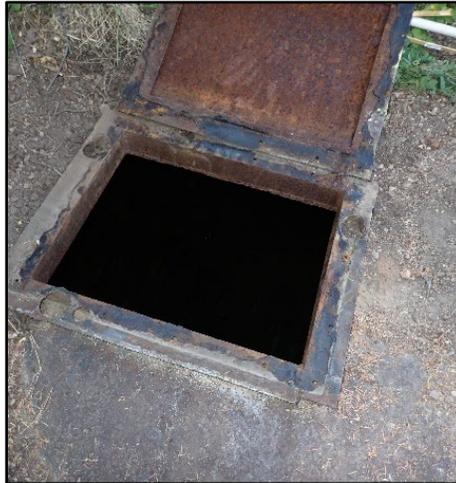
Photograph 6. Sierra Los Pinos HOA

Description: Storage Tank #2 – 011 access hatch photograph provided by Sierra Los Pinos HOA from a 2023 inspection. Hatch is at ground level and has an incomplete and deteriorated seal.

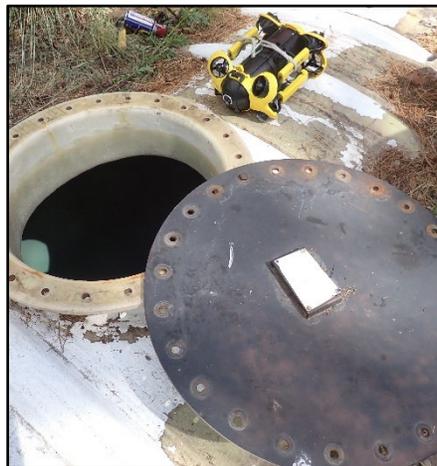
Photograph 7. Sierra Los Pinos HOA

Description: Storage Tank #1 – 010 access hatch photograph provided by Sierra Los Pinos HOA from a 2023 inspection. Hatch does not have an observable seal.

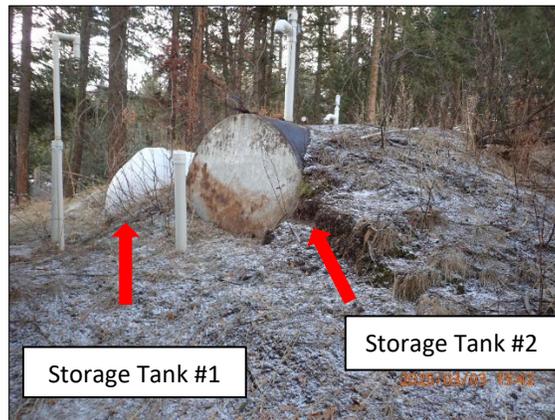
Photograph 8. Sierra Los Pinos HOA

- a. Storage Tank #1 – 010 – No overflow observed.
- b. Storage Tank #2 – 011 – No overflow observed.
- c. Storage Tank #3 – 012 – No overflow observed.
- d. Storage Tank #4 – 013 – No overflow observed.
- e. Storage Tank #5 – 014 – No overflow observed.

Description: Storage Tank #1 – 010 and #2 – 011 shown, each with multiple vents and other pipe attachments at or above the tops of the tanks. Overflow locations were not known.

6. **Notes & Recommendations:** It is highly recommended that the woody vegetation be maintained on and around the partially buried Storage Tank #1 – 010 and Storage Tank #2 – 011. Refer to Photograph 8.

Required Corrective Action: Sierra Los Pinos HOA must submit to NMED DWB descriptions of how the storage tanks are designed to overflow and photographs that any overflow outlets are properly constructed and screened.

Recommended Action: Sierra Los Pinos HOA should routinely maintain all vegetation that could impact the operation and maintenance of the storage tanks.

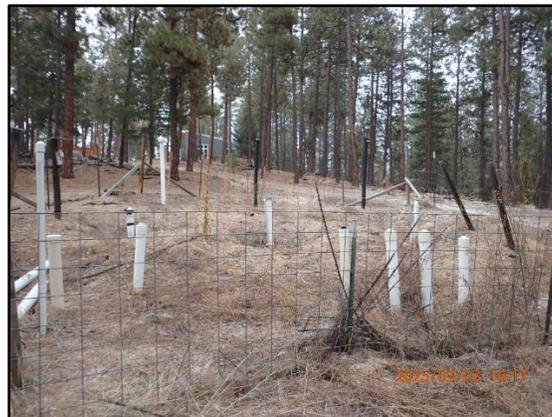
Photograph 9. Sierra Los Pinos HOA

Description: Storage Tank #3 – 012, #4 – 013, and #5 – 014 are buried tanks within the fence line. Each tank is equipped with multiple vents and other pipe attachments above the tops of the tanks. Overflow locations were not known.

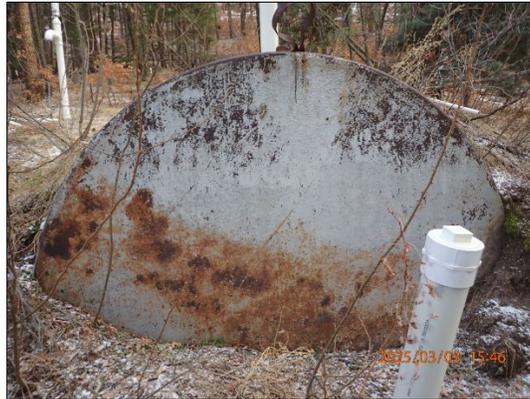
Photograph 10. Sierra Los Pinos HOA

Significant Deficiency Description: The Storage Tank #2 – 011 has interior and exterior corrosion. Failure of storage facility will result and water outage; leaks in an area with no water pressure can result in the introduction of foreign materials into the facility.

Description: Storage Tank #2 – 011 corroded exterior sidewall of the partially buried steel tank.

Required Corrective Action: Sierra Los Pinos HOA must submit to NMED DWB a plan to address the reliability of the corroded storage tank.

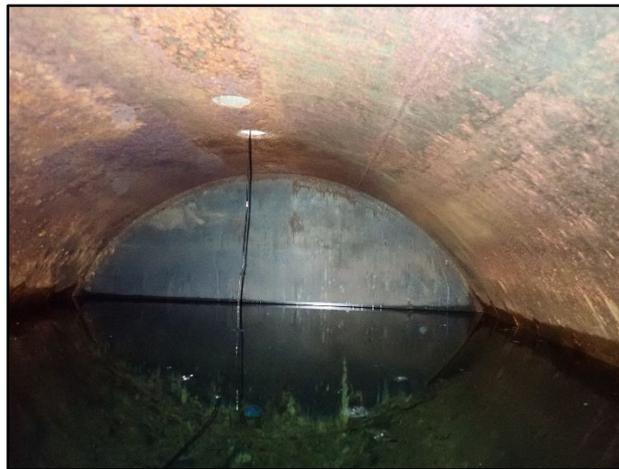
Photograph 11. Sierra Los Pinos HOA

Description: Storage Tank #2 – 011 photograph provided by Sierra Los Pinos HOA from a 2023 inspection. Corroded interior sidewall above water level.

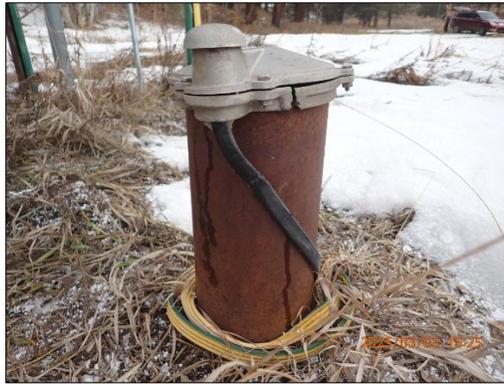
Photograph 12. Sierra Los Pinos HOA

4. **Notes & Recommendations:** It is highly recommended that the Distribution System 2 inactive well be properly abandoned and physically disconnected from the water system. It was observed to be actively venting during the sanitary survey and had a cracked well cap.

Description: Inactive well in Distribution System 2 that is not properly abandoned and is physically connected to the water system.

Recommended Action: Sierra Los Pinos HOA should submit to NMED DWB a plan to properly abandon and physically disconnect the well from the water system.

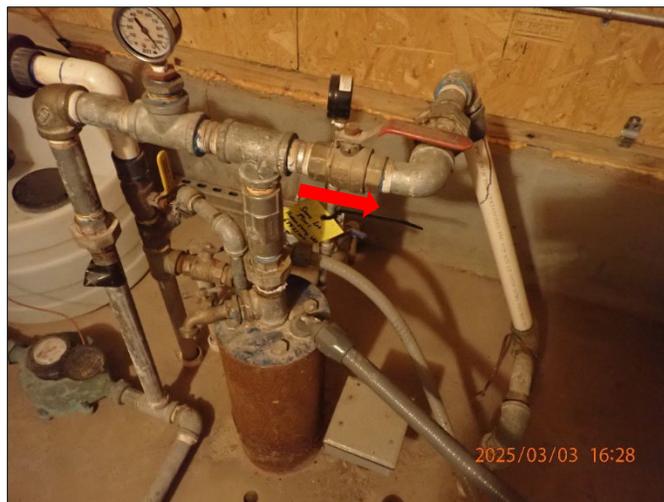
Photograph 12. Sierra Los Pinos HOA

7. **Notes & Recommendations:** It is highly recommended that the unchlorinated Hovenweep Well – 002 discharge line be confirmed as out of service and isolated to prevent serving undischlorinated water.

Description: Hovenweep Well – 002 has a discharge line shown with the callout arrow that bypasses disinfection.

Recommended Action: Sierra Los Pinos HOA should investigate the destination of the unchlorinated discharge line and isolate it to remove it from service.
